NASA Contractor Report 185262 Aerojet 2459–56–1

# Orbital Transfer Vehicle Oxygen Turbopump Technology

Final Report, Volume II—Nitrogen and Ambient Oxygen Testing

GENCORP Aerojet TechSystems

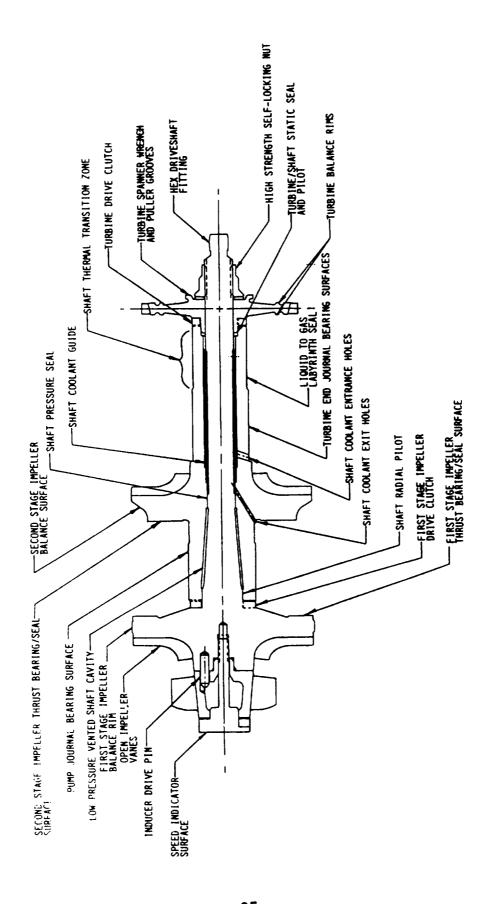
Figure 3.5-3. OTV OTPA Rotating Assembly

The turbopump disassembly was completed and the condition of the major parts are shown in Figure 3.5.2. The general condition was excellent with some local rubs on the journal bearings, shaft journals and impeller vane mating contours. The rotating assembly cross section is shown in Figure 3.5.3 and the rotating assembly after testing in Figure 3.5.4. The turbine end journal surface shows minor scratches and the pump end journal surface shows the burnish work from the balancing procedure and a small groove towards the pump end of the journal. A close up of these two journal surfaces are shown in Figures 3.5-5 and 3.5-6. A profile of the turbine end surface is shown in Figure 3.5-7 indicating minor scratches. An axial profile trace at the pump end journal surface is shown in Figure 3.5-8. This shows a sharp groove approximately .0013 in. deep at the approximate axial location of the pocket to exit land entrance. This groove would suggest a particle possibly trapped in the pocket wearing on the chrome coated shaft surface.

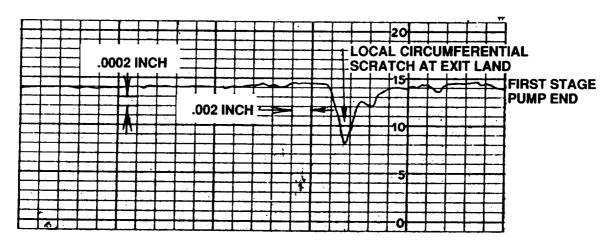
Figure 3.5-8. Profile of Pump Bearing Journal Surface Along Shaft Axis

Since upon disassembly the upstream pump bearing filter was found to be ruptured and since the pressure drop across this filter was higher than the turbine filter and varied with time, it is concluded that hard debris passed through the pump journal bearing and caused the exit land wear.

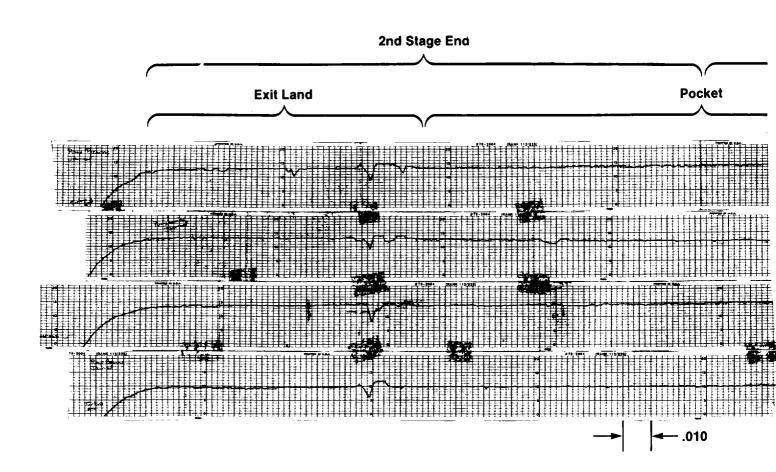
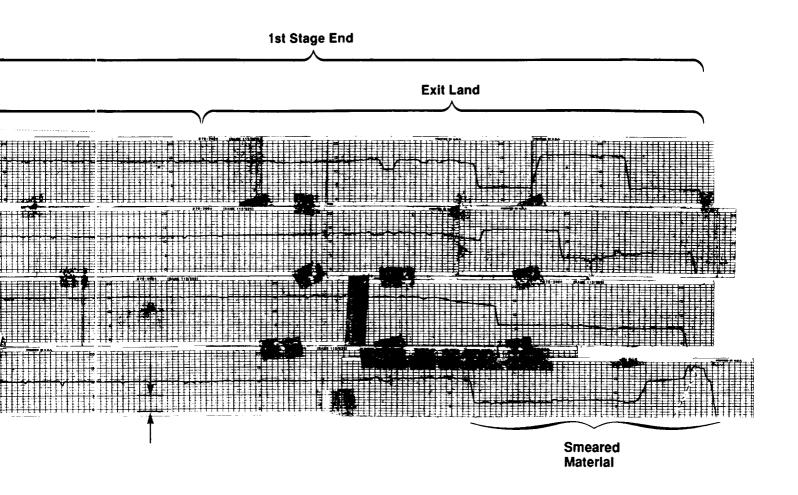
Figure 3.5-16. Pump Bearing Journal Profile

Close up photos of the pump bearing from the first stage side,
Figure 3.5-14, and from the second stage side Figure 3.5-15 show that the wear occurs
at the first stage exit land. A significant portion of the silver plating on the exit land
has been removed or smeared in the circumferential direction. An axial surface
profile across the bearing bore between the four pockets is shown in Figure 3.5-16.
From these profiles and the photos it is obvious that the predominant wear
occurred on the exit land. The rest of the bore is close to original condition. It
appears that once wear started on the exit land the debris moved circumferentially
removing the silver plating. Mentioned earlier was the fact that a groove was
carved in the chrome coating on the shaft. This would indicate a hard particle to
wear a groove in the hard chrome surface. With this exit land worn the journal
bearing flowrate will increase. Subsequent disassembly of the pump end bearing

supply filter showed a ruptured filter element. In addition, the pressure drop on
this filter was higher than the turbine end filter and also varied with time. The conclusion is that debris passed through the pump journal bearing.

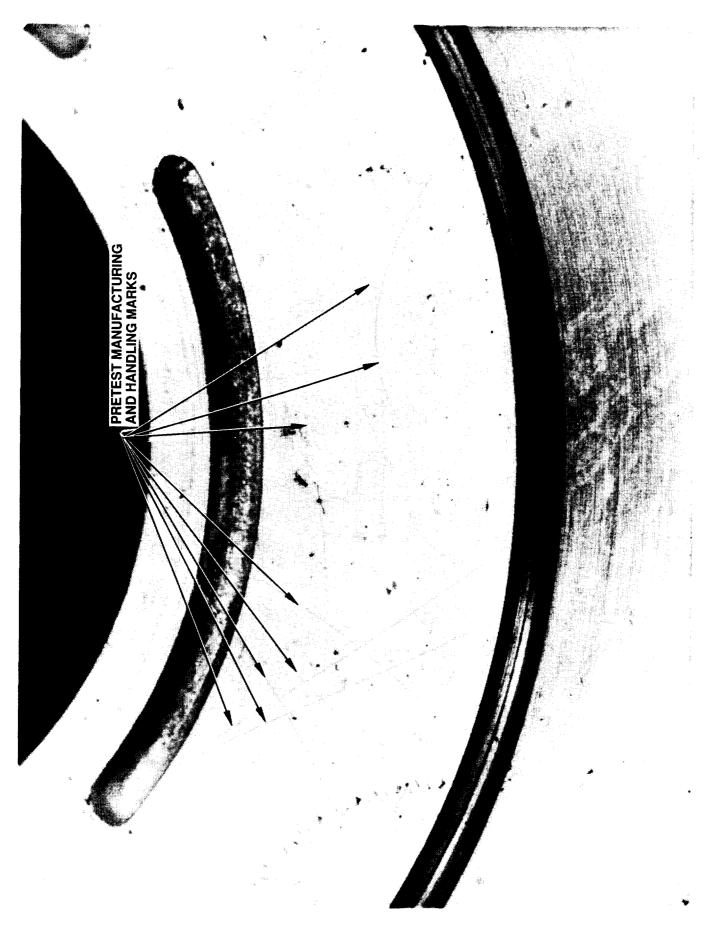
The first stage thrust bearing is shown in Figure 3.5-17. There is some scuffing of material between the pockets and the mating rotating surface and this is the highest loaded bearing surface during the start transient. There are slight burnish marks on the inlet and exit lands. The second stage thrust bearing surface is shown in Figure 3.5-18. This surface shows some minor circumferential scratches between pockets and just inside the pockets. In evidence are random surface scratches that have occurred during manufacturing and handling over the past two years.

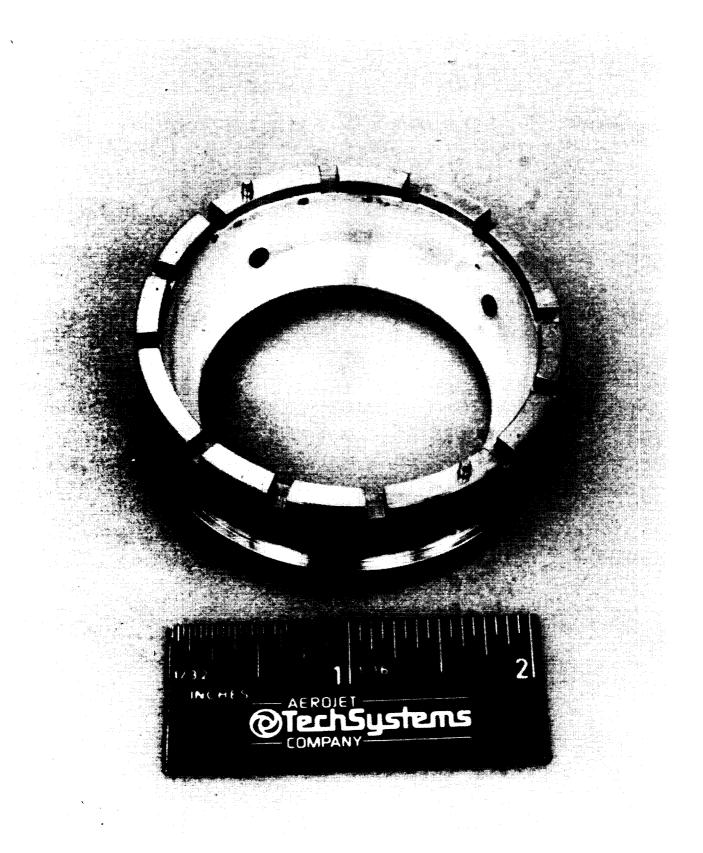
Figure 3.5-19. Pump Bearing Housing ATC Photo #C0489 1872

The pump bearing cup is shown in Figure 3.5-19. The silver sphere is in excellent shape but with several discoloration marks near the sphere outside diameter. These marks are shown close up in Figure 3.5-20. Contact scratches were evident in this zone with corresponding discolored marks on the pump bearing sphere. Contact at this location on the sphere is a logical condition. This location on the sphere is at a maximum diameter and the radial clearance is not adjustable. The axial clearance is adjustable to compensate for increasing load with increasing pump pressure. In addition as axial load is applied to the bearing cup the cup tends to twist about a diametral axis inward at the maximum diameter. Contact locations are diagrammed in Figure 3.5-21 for the sphere and the pump journal bearing. Light contact is not considered detrimental.

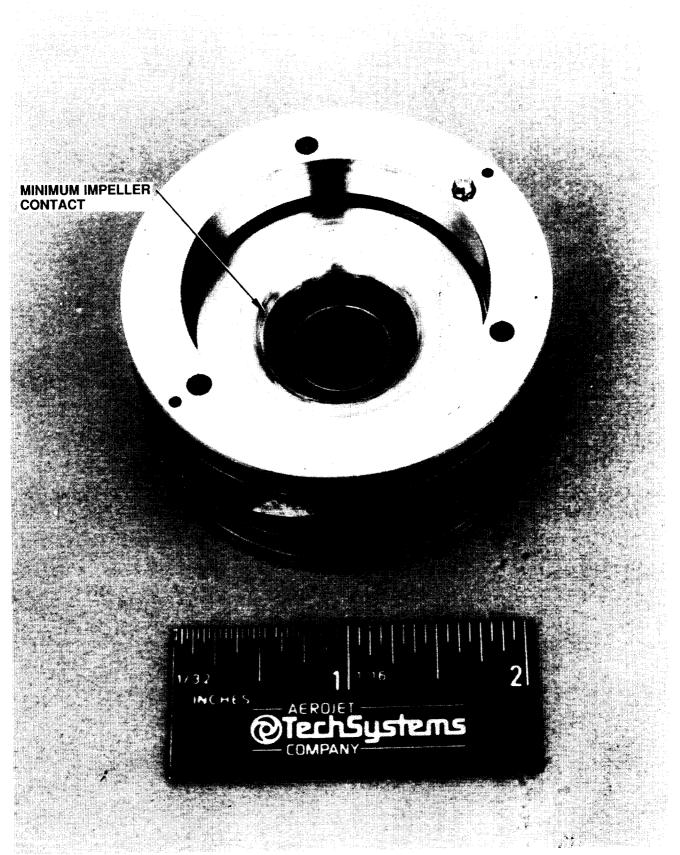
Figure 3.5-22. Second Stage Impeller Housing

The second stage impeller housing shown in Figure 3.5-22, is in excellent condition. Two things were found on this part. First, there was slight trace of discoloration in the pump inlet and a small amount in the bearing area. This substance was a very thin tan powder (oxidation?). There was the same substance in the first stage diffuser passage but not in the crossover passages. Second, a small amount of impeller vane contact on the silver housing contour was experienced. This minute contact is shown close up in Figure 3.5-23. This contact occurred where the radial surface of the impeller housing contour enters the housing inner radius. This was the point of minimum clearance during the turbopump assembly and probably contacted during assembly.

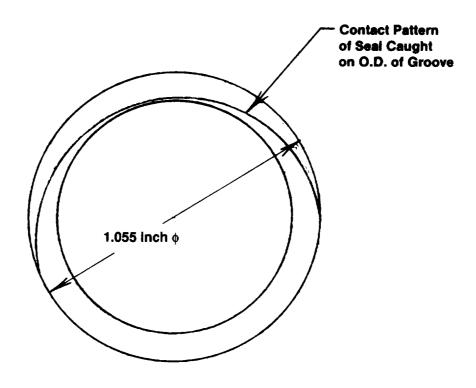
Figure 3.5-27. Turbine Nozzle "V" Seal

The turbine nozzle was in very good condition. Some difficulty was experienced with the gas piston ring seal, the location of which is identified in Figure 3.5-26. The piston ring was a two piece design, a seal ring, and an expander ring. The assembly of this ring was deep inside a blind housing and the expander ring held the seal ring out of the groove and could never be assembled. Therefore a modification was made to the end of the nozzle piece to accept a metal "V" seal. The nozzle end surface and the mating housing had about .010 inch clearance when assembled. The "V" seal was the same seal used for the turbine discharge flanges. Since the mating surfaces have clearance the seal groove depth was selected accordingly. On disassembly of the housing the seal appeared to have been offset in the groove, Figure 3.5-27. It is possible that a complete seal was not made and that some portion of the turbine flowrate bypassed the turbine through this seal. It appears that the groove O.D. was too small for the O.D. of the compressed "V" seal. It is recommended that this diameter be opened prior to the hot GOX test series at White Sands Test Facility (WSTF).

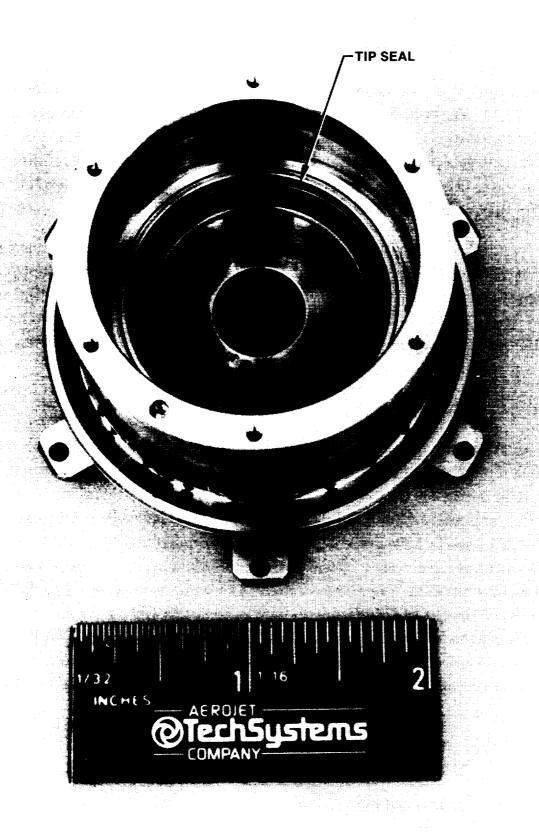
Figure 3.5-30. Turbine Tip Seal Post-Test

The mating turbine housing is shown in Figure 3.5-29 looking from the turbine inlet. This part is in excellent condition with no contact at the shaft labyrinth gold wear surface. A close up view of the turbine tip seal is shown in Figure 3.5-30. The gold tip seal surface has a small circumferential groove at the entrance to the turbine blades. Since there are no marks on the turbine blades it is possible a particle passing through the turbine made this mark. The axial scratches seen on the gold seal surface are from the shim material used for determining the installed turbine tip clearance.
